Misdeclared or undeclared Dangerous Goods cargoes

Undeclared hazardous cargo

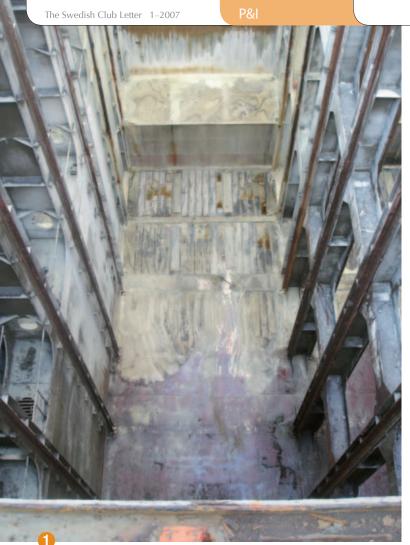
Widespread contamination of surrounding areas in the cargo hold.

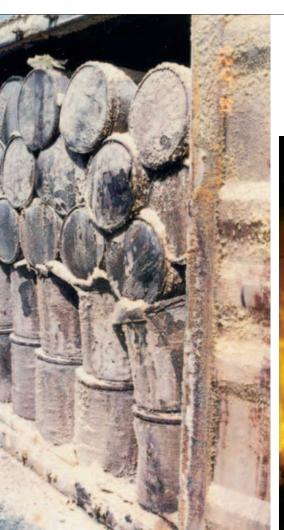
There have been several incidents involving the spontaneous exothermic decomposition of thiourea dioxide manufactured in China. The material, carried in drums in containers, was not originally listed as an IMDG cargo. Products of the reaction are highly toxic sulphur dioxide gas and sulphur, the latter of which caused widespread contamination of surrounding areas that required expensive remedial action (see photograph **1**). For these reasons the material was frequently refused for carriage. In the circumstances some Chinese shippers simply changed the name of the chemical to "thiourea DE or "thiourea D", claiming incorrectly that these materials had a different chemical formula from thiourea dioxide and that they do not have the same hazardous properties. In one incident the container of decomposed thiourea dioxide shown in photograph ⁽²⁾ was declared on the manifest to contain toys.

This container was declared to contain toys!

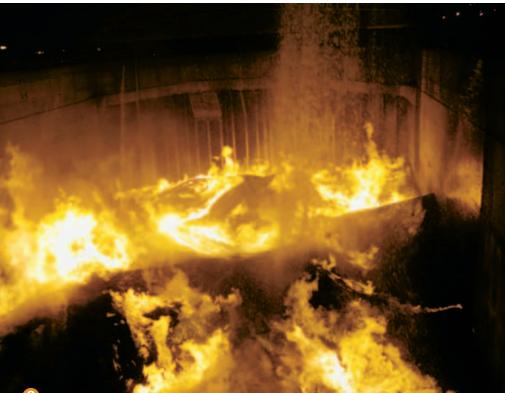
Spectacular fire – in this case DRI derivatives are involved.

In February 2004 the Ythan, a 35,310 dead weight bulk carrier, loaded a cargo variously described as "metallic HBI fines" (the bill of lading), "Orinoco iron remet fines", "remet fines (HBI"), "Orinoco remet fines in bulk" and "HBI fines". The master was given written advice that "Orinoco Iron remet fines, to be loaded on your vessel are safe to transport without the use of inert gas or other special precautions". On February 28th 2004 the motor vessel Ythan experienced a series of violent explosions in the cargo holds when the vessel was north of Santa Martha, Columbia. The vessel's master and five engine room personnel were killed and the ship sank. The cargo should have been described as a DRI (Direct Reduced Iron) derivative (e.g. DRI fines) that evolve hydrogen when wet and yet the term DRI was absent from any of the cargo descriptions given in this case. The more cynical amongst us may wonder whether the term HBI Fines was chosen to claim the relaxation in conditions of transport afforded to HBI. Fires involving DRI derivatives can be very spectacular as illustrated in photograph **(**).
