**ALARM JOURNAL**

February
2021

Investigating white goods' FIRES

AUTHOR: **Ian Wallis-Guy**, Partner, Burgoynes.

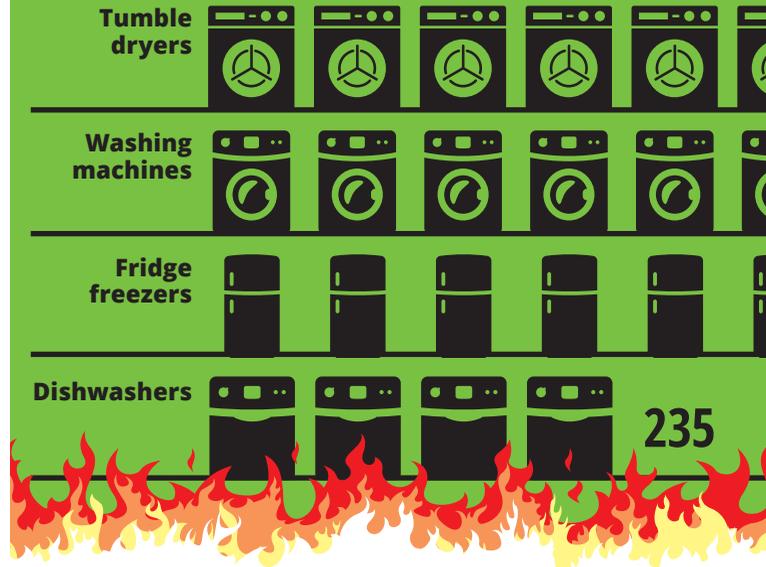
Fires in England in 2019/20 by appliance

Government statistics for England¹ in 2019/20 show there were 3,862 fires in dwellings caused by faulty appliances and leads. Over half were determined to have originated at tumble dryers, washing machines, fridge freezers and dishwashers - white goods.
