**Fire Protection
Association**

Fires in Thatched Properties with Wood Burning Stoves

Dr James LD Glockling

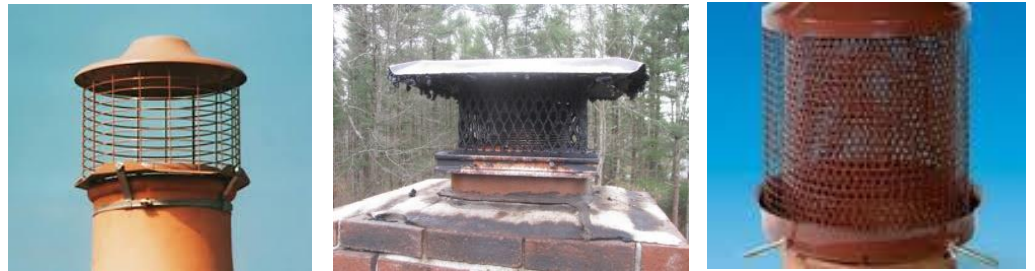
Applies to the intermittent drop-off of hot / burning condensed material (tar) from the underside of a 'Chinese hat' rain guard, or spark arrestor assembly on to the thatch. Unlike a spark emanating from the chimney such deposits will be heavy with much higher energy densities. Contributing factors to tar build up might include inappropriate fuel selection, product design, poor maintenance or installation. Initiation might commence through poor stove management (high temperatures and high velocities).

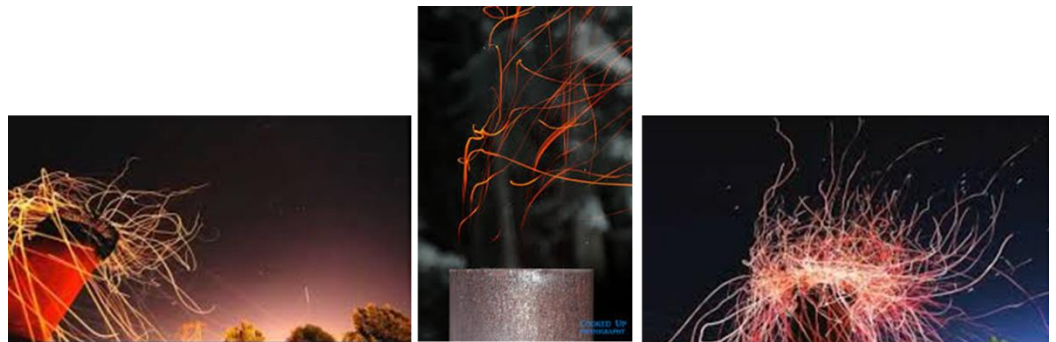
Applies to the emission of sparks, embers, and hot solid materials from the stack which then fall back onto the thatch with enough energy at given conditions to ignite the thatch. Contributing factors to emission might include fuel type, fuel disturbance and ventilation regime. Ignition propensity might be influenced by weather conditions, thatch condition, age, and type.

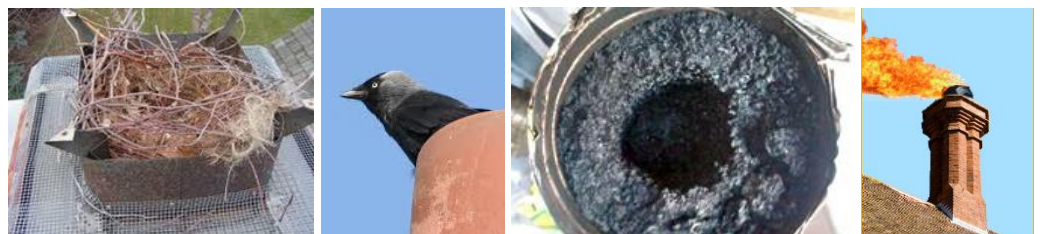
Applies to conditions that lead to flaming and fire product emission at the stack which may ignite the thatch by radiation or dropping of flaming material. May work in association with physical mechanisms described above. Examples might include:

- Chimney fire (ignition of soot/tar lining)
- Birds nest / blockage fire

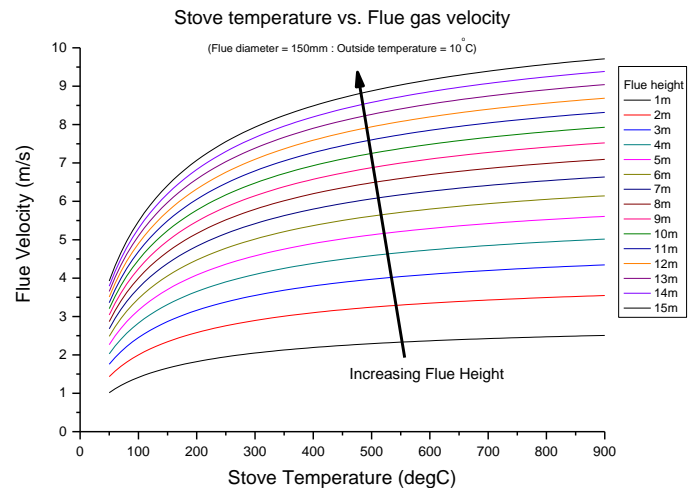
Figure 2 - Correlation between Stove temperature and Flue gas velocity for a range of flue heights

Flue velocities are observed to increase with decreasing outside air temperature, although the function is relatively weak, and increases strongly with increasing chimney height. The determination of gas velocity (or gas flowrate) is an important consideration for this study as it can impact:

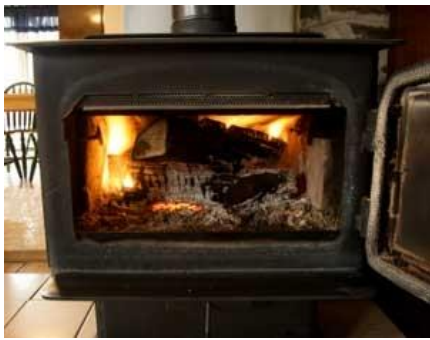
Figure 5 - Example of a wood / log burning stove with no ash-pan

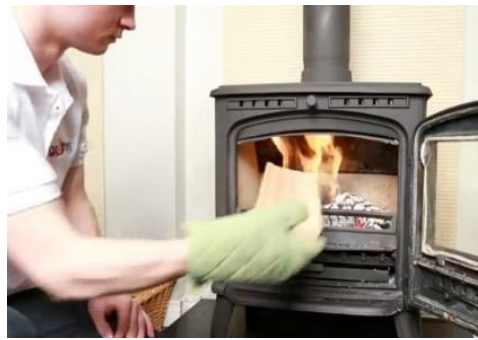
Figure 6 - Example of multi-fuel stove with single door providing access for fuel loading and ash-pan removal

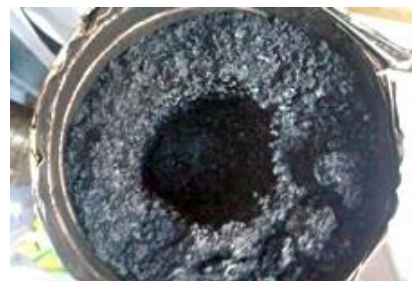
- **Soot build-up in the chimney** which might lead to a chimney fire. The restriction of cross section might also act to encourage the user to more aggressively ventilate their fire over time as the draw gradually reduces with deposition. Soot build up may be prevalent where sweeping regimes are not followed or inappropriate fuels are burned.

Figure 13 - Tarred up chimney liner

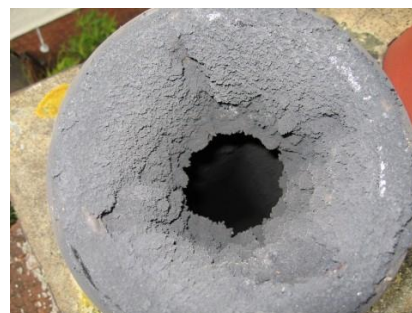
- **Soot sweeping annulus build up** if repeated sweeping fails to clean to the very top of the chimney. This will act to reduce the draw of the chimney and encourage the user to gradually increase ventilation over time. It may contribute to a 'near-pot' fire or force hot gases out of damaged chimney brickwork and into the thatch by restricting gas from exiting at the top. Sweeping annuli often form where there are concerns about dislodging cappings and bird guards during cleaning.

Figure 14 - Chimney sweeping annulus

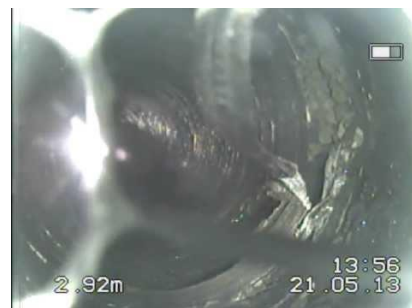
- **Corrosion / splitting of the liner** will allow fire gases to escape into the cavity between liner and brickwork. This might raise brick temperatures and if the brickwork / mortar is imperfect might allow hot fire gases to gain direct access to the thatch. Corrosion may be accelerated through the adoption of poor quality materials and inappropriate fuel supply, or be due to wear and tear associated with its age.

Figure 15 - Split chimney liner

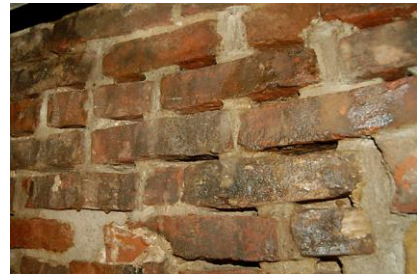
- **Deterioration of render, mortar and brickwork** might enable fire gases, or secondary heated gases if lined, to gain direct access to the thatch material. The impact on the thatch will be to heat it and deposit fire products which might result in fire.

Figure 16 - Imperfect mortar in brickwork

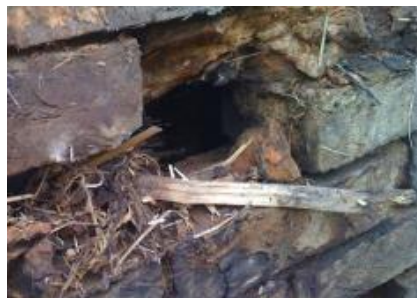
- **Liner slump / slippage.** Liners should ideally not touch the internal brick surface of the chimney since the benefit of an insulating air partition is lost at this location and brick temperatures will be expected to be higher. This might act to transfer more heat into the thatch layer by conductive modes. Most flexible liners, being supplied coiled, will make contact with the stack at several points particularly in narrow and angled chimneys where spacers cannot be used.

Figure 19 - Liner found to be in contact with chimney brickwork

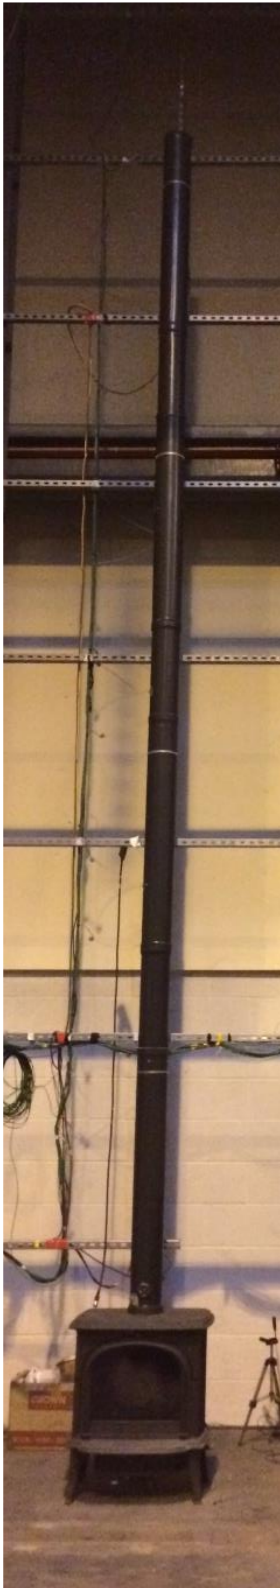
6.1 Operational Basics and Ember Transport Rig (OBETR)

The OBETR was constructed based around the Stovax Huntingdon 40 multi-fuel stove rated at 12kW output. The stove is characterised by a separate ash-pan door with ventilation by over-fuel air wash and bottom vent. The chimney was constructed entirely of mild steel stove pipe which, for this study was convenient for the mounting of sensors. Stove pipe is normally only used for the short section between the stove top on the flue liner situated above the fireplace's register plate.

The OBETR is intensely instrumented to describe every aspect of its operation. The requirement was to be able to establish cause and effect scenarios and understand completely the changes that were taking place within the heating system together with magnitude measurements.

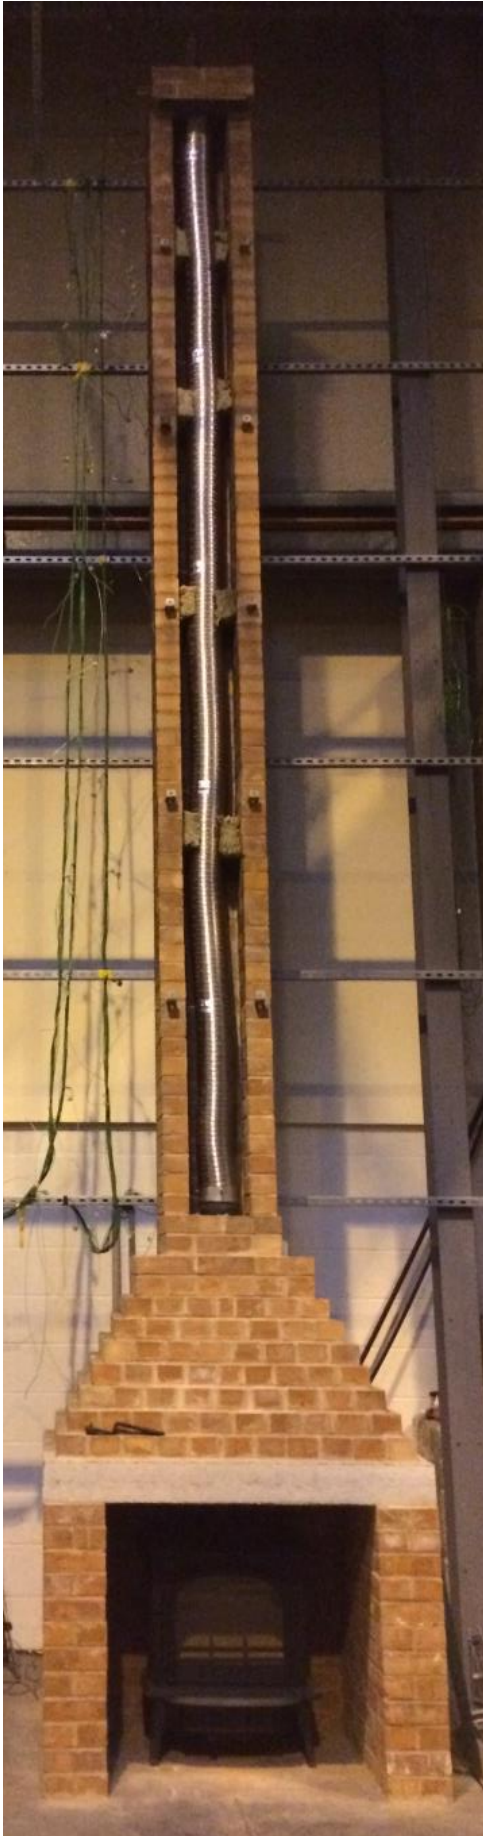
6.2 Convection and Conduction mode test rig (CCMTR)

The CCMTR was again based around the Stovax Huntingdon 40 multi-fuel stove rated at 12kW output but this time the chimney detailing was changed to allow detailed examination of the influences of liners in brick chimneys. The fireplace was additionally constructed to enable future examination of 'open fire' scenarios.

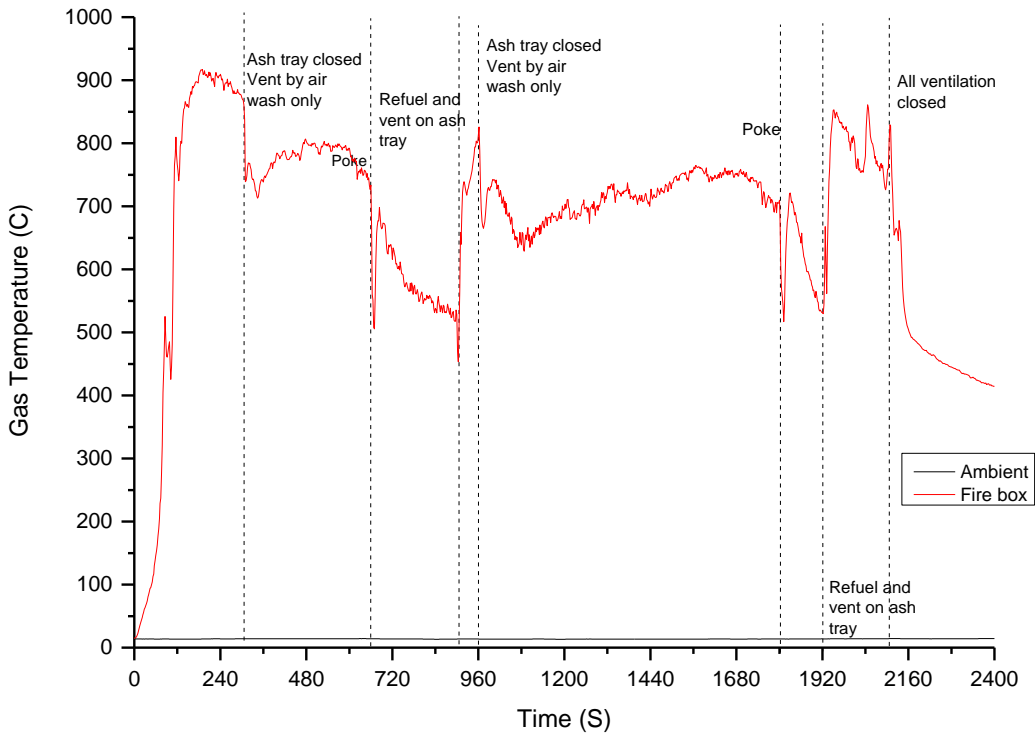
Fire box temperature

- Opening the fuel loading door of the stove to gain access to poke the fire immediately drops the temperature within the firebox and stove as fresh cool air is drawn in over the fuel and up the flue. An inversion is noted at 3 metres above which the already low temperatures momentarily increase.

Test 003 - Normal operation with refuelling and poking

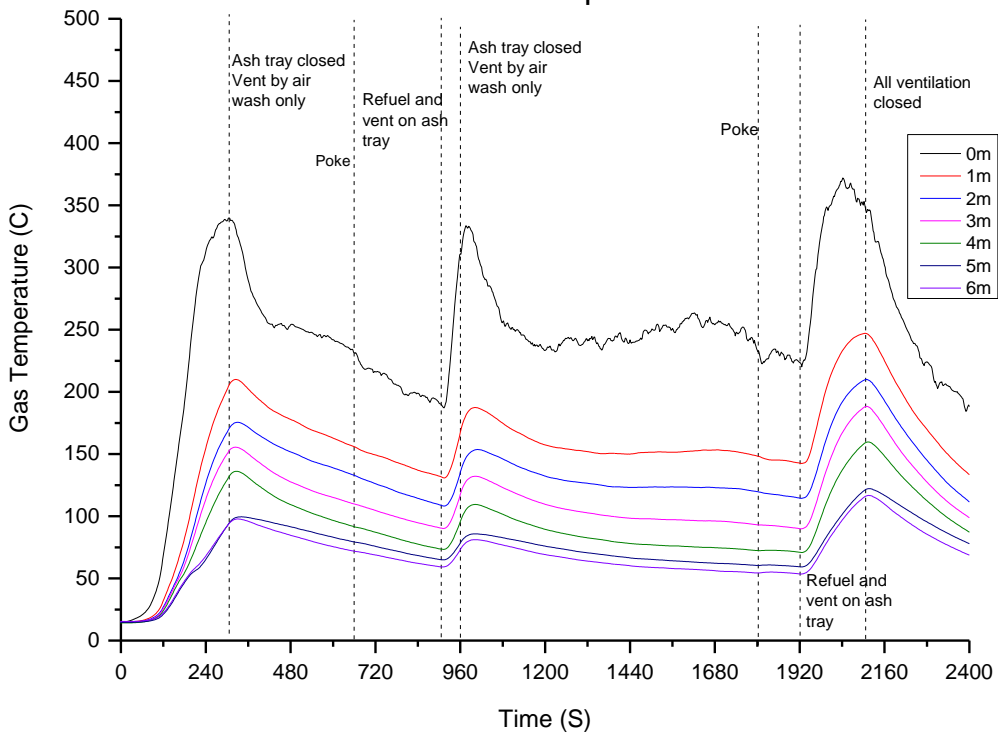
Flue wall temperatures

Test 003 - Normal operation with refuelling and poking

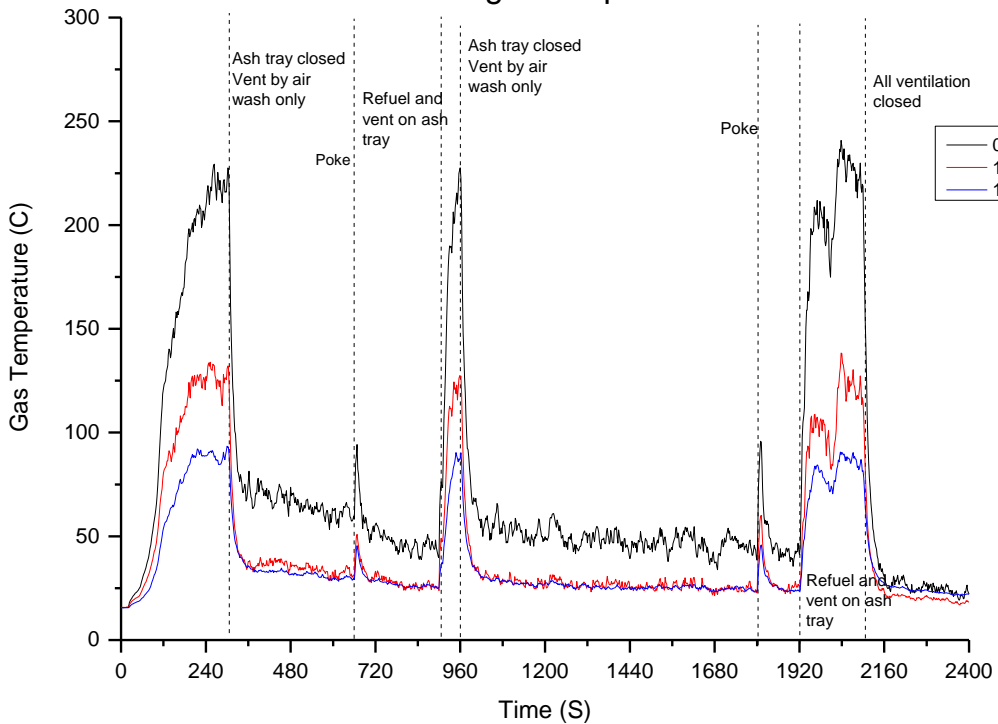
Plume gas temperatures

Test 003 - Normal operation with refuelling and poking

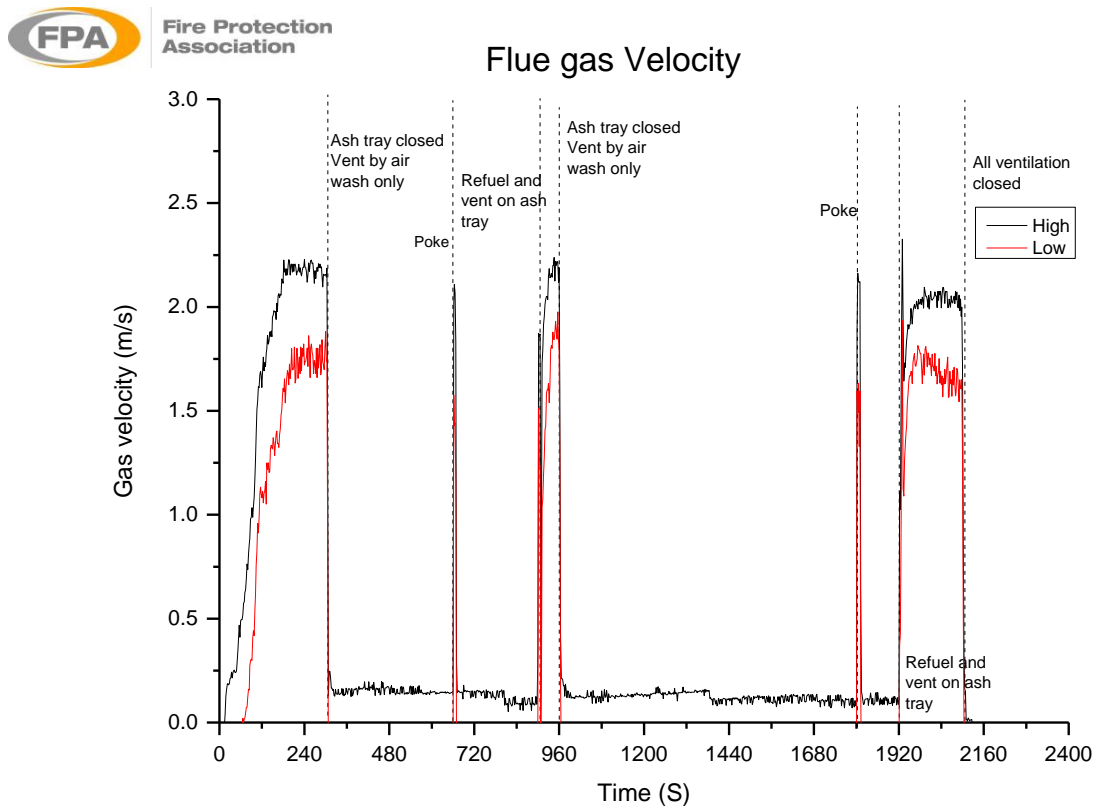
- During aggressive ventilation at the time of ignition velocity increase is rapid yet steady and flattens out at the point where temperatures in the firebox stabilise
- On closing the ash-pan door the reduction in gas flow is immediate
- Once heated up (following ignition), and additional ventilation of the stove by fuel loading door or ash-pan door immediately causes an instantaneous increase in gas velocities.

Test 003 - Normal operation with refuelling and poking

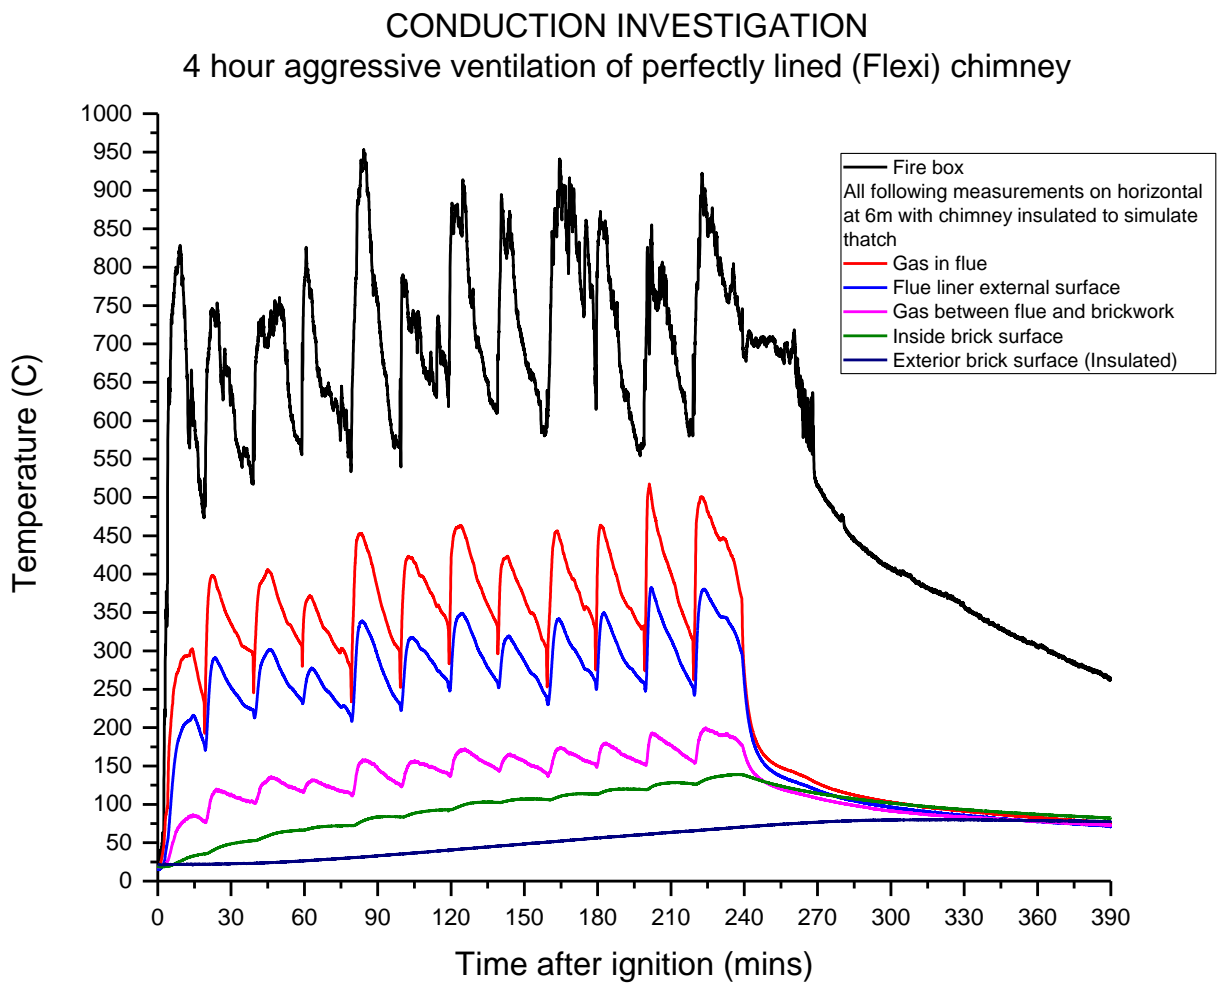
- Maximum temperature achieved at each measurement point after 4 ½ hours of operation are as follows:
 - Firebox – 950°C
 - Flue gas – 500°C
 - Flue liner external surface – 400°C
 - Gas space between liner and brickwork – 200°C
 - Internal chimney brick surface – 150°C
 - Insulated external chimney brick surface – 80°C

Figure 34 - Conduction investigation for perfectly lined uninsulated fuel

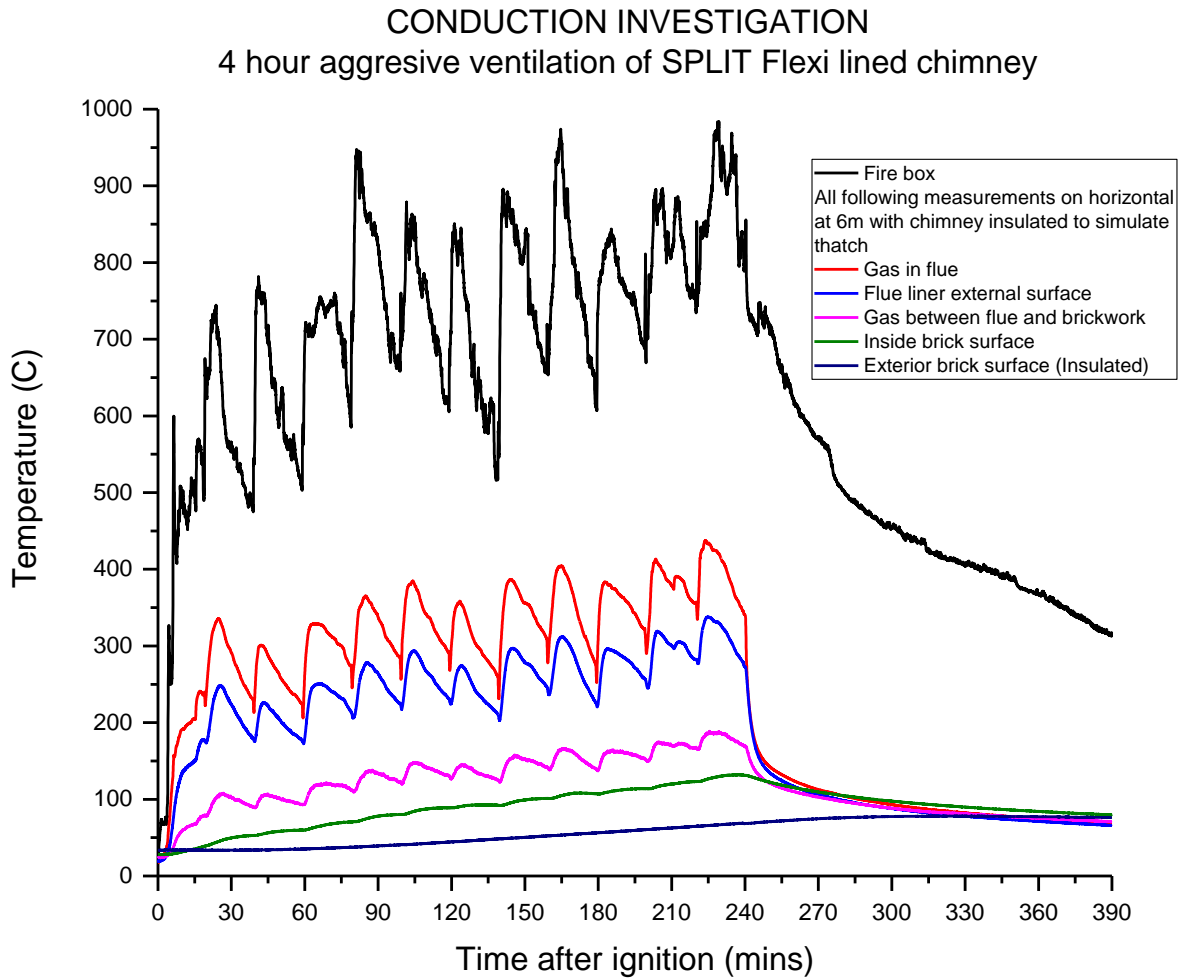
With the flue liner now significantly split through and bent to expose 50% of its cross sectional area the test was conducted in accordance with the criteria detailed in Section 0. The results are shown in Figure 35.

Error! Reference source not found.
Figure 35 - Conduction investigation for a split liner

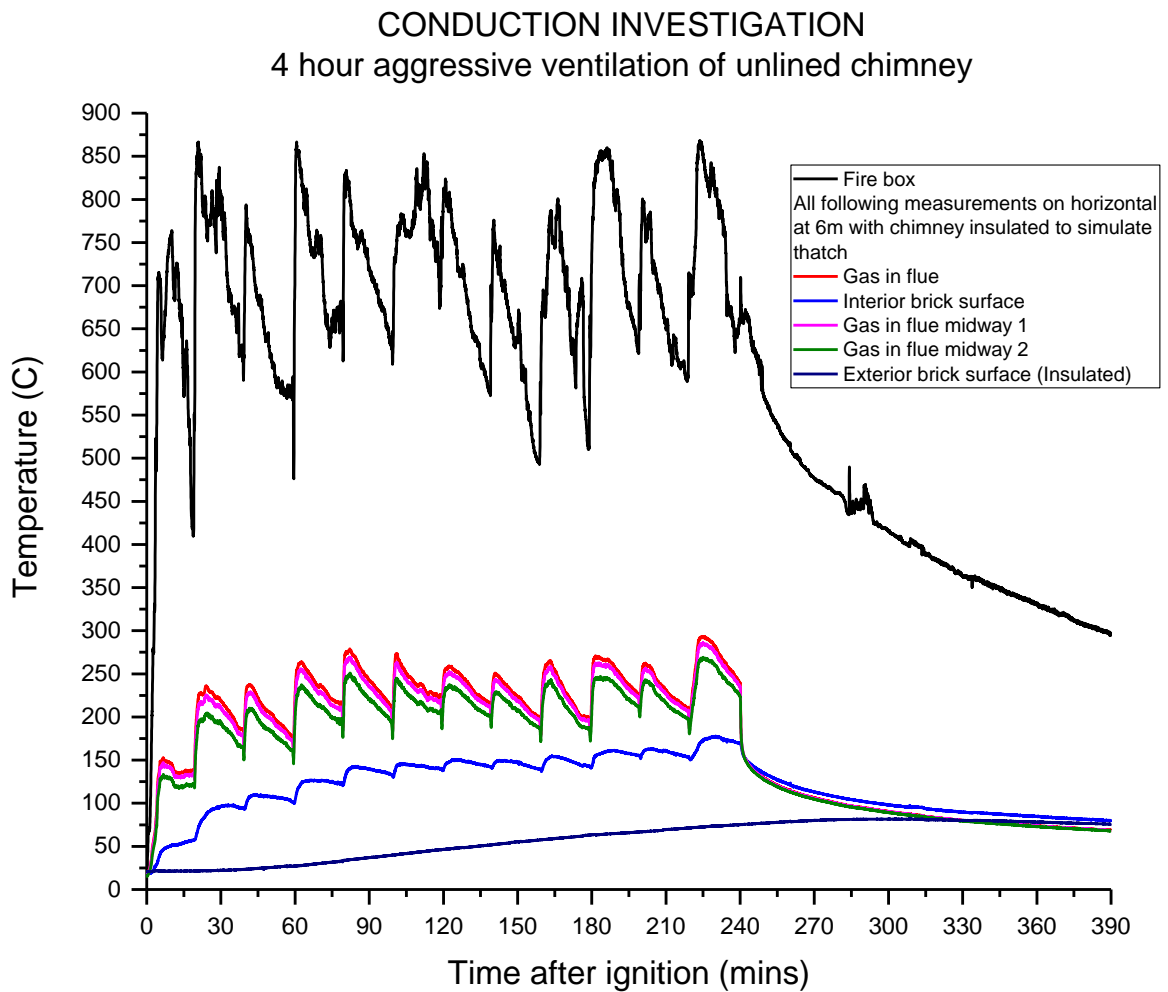
- Maximum temperature achieved at each measurement point after 4 ½ hours of operation are as follows:
 - Firebox – 900°C
 - Flue gas – 300°C
 - Internal chimney brick surface – 200°C
 - Insulated external chimney brick surface – 80°C

Figure 36 - Conduction investigation for an unlined chimney

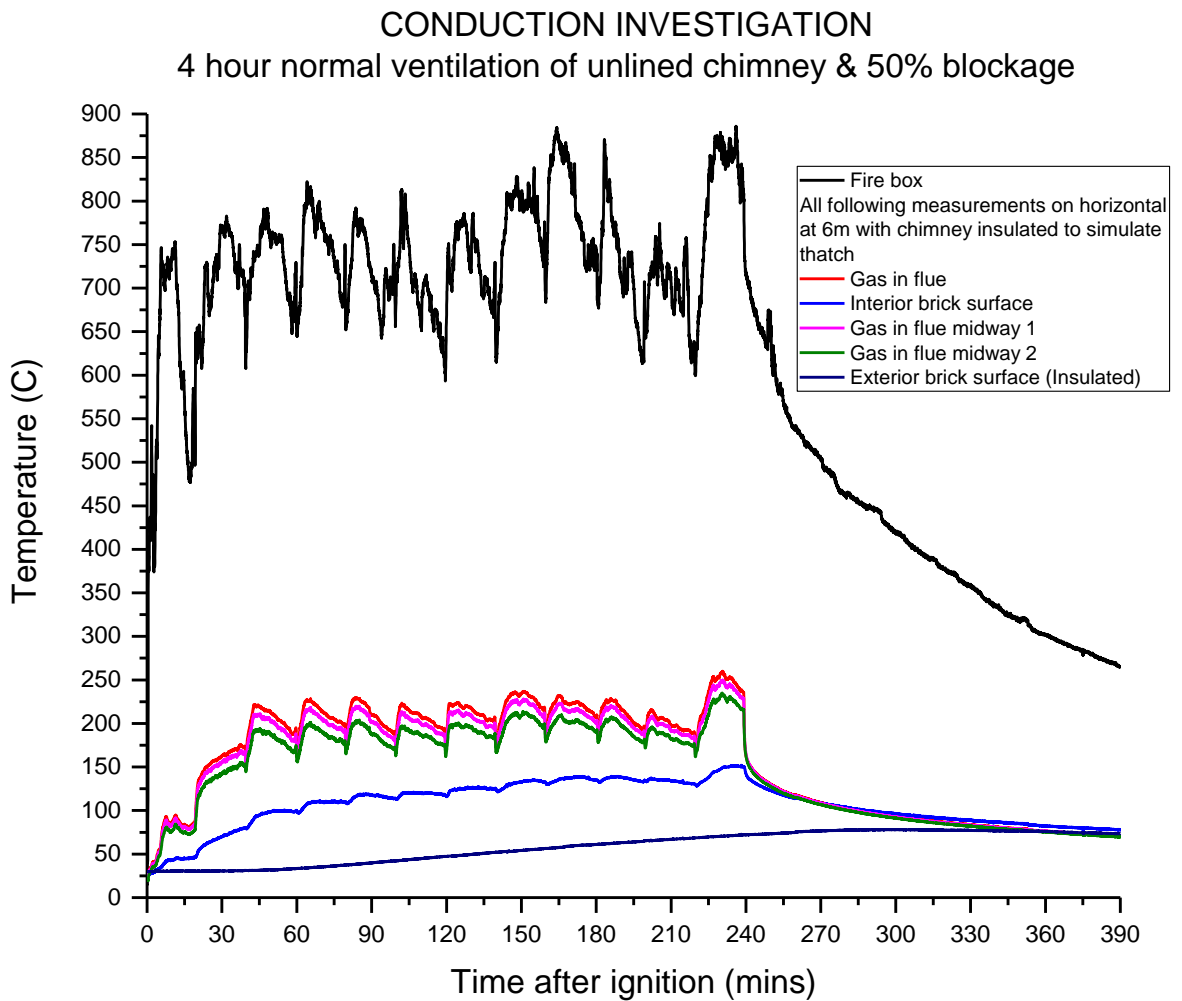
- Maximum temperature achieved at each measurement point after 4 ½ hours of operation are as follows:
 - Firebox – 900°C
 - Flue gas – 275°C
 - Internal chimney brick surface – 175°C
 - Insulated external chimney brick surface – 80°C

Figure 37 - Conduction investigation for an unlined chimney with 50% blockage

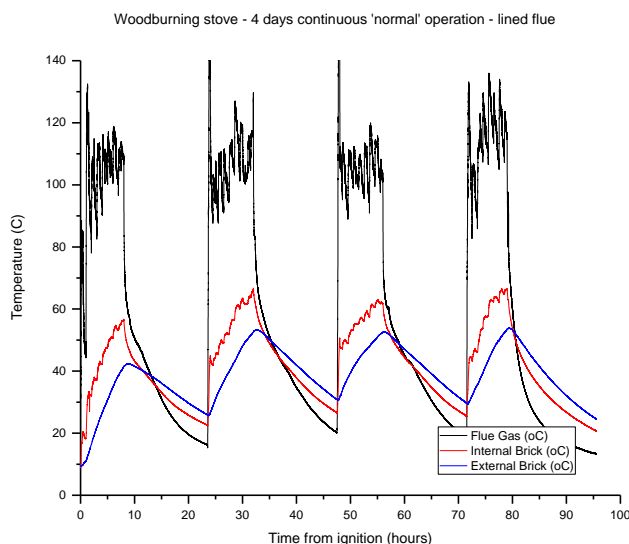
Figure 38 - Long Duration conduction investigation for a lined chimney

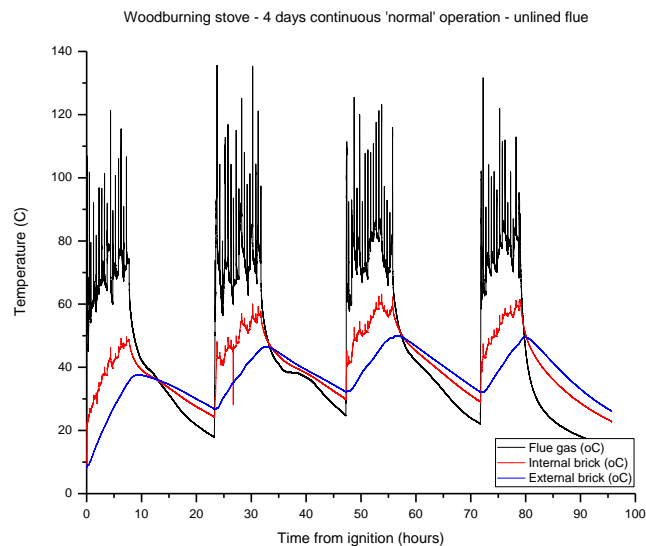
Figure 39 - Long Duration conduction investigation for an unlined chimney

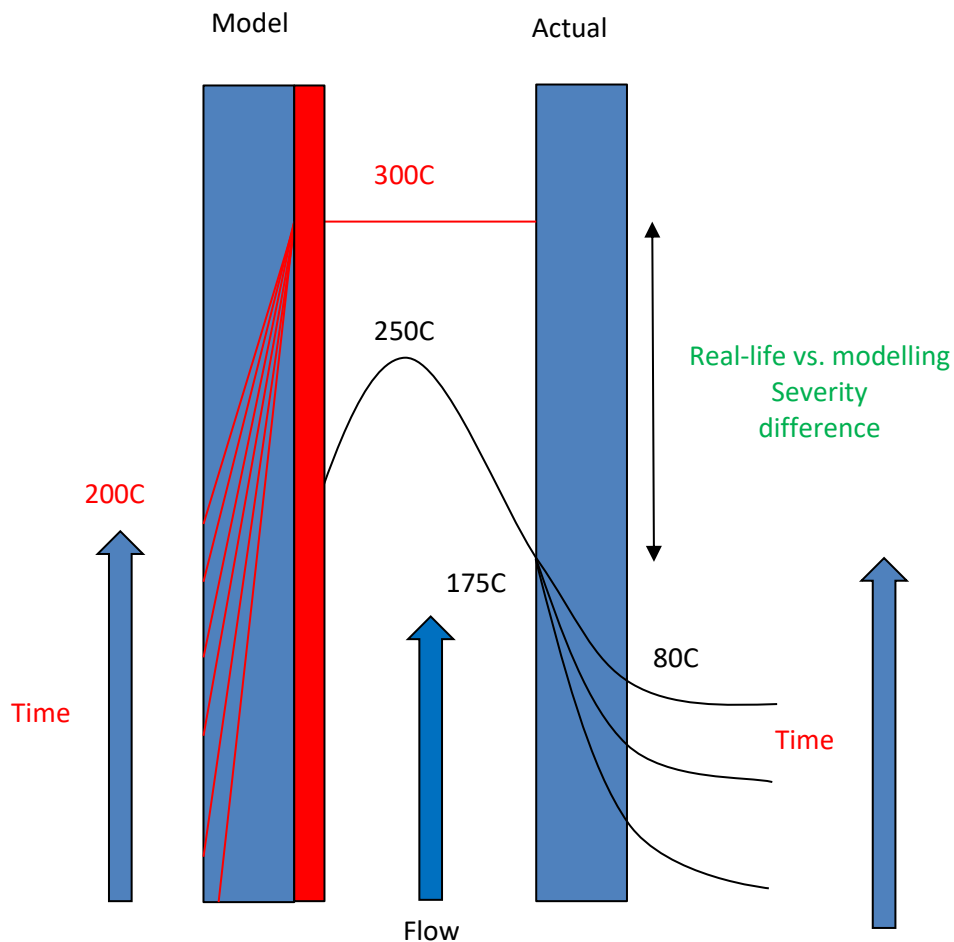
Figure 40 - Comparison of inputs of historic conduction work with full-scale measurements

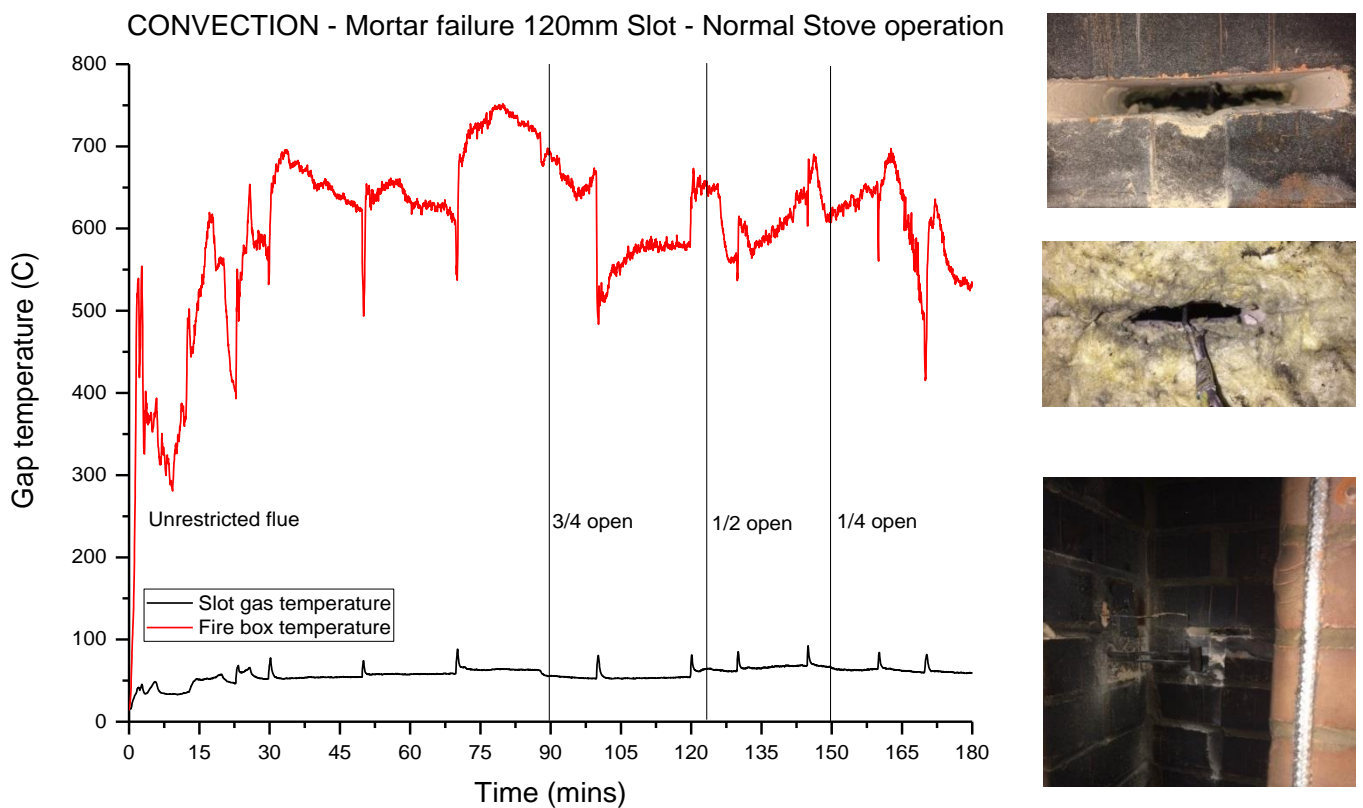
Figure 41 - Convection test through failed mortar joint with normal stove operation

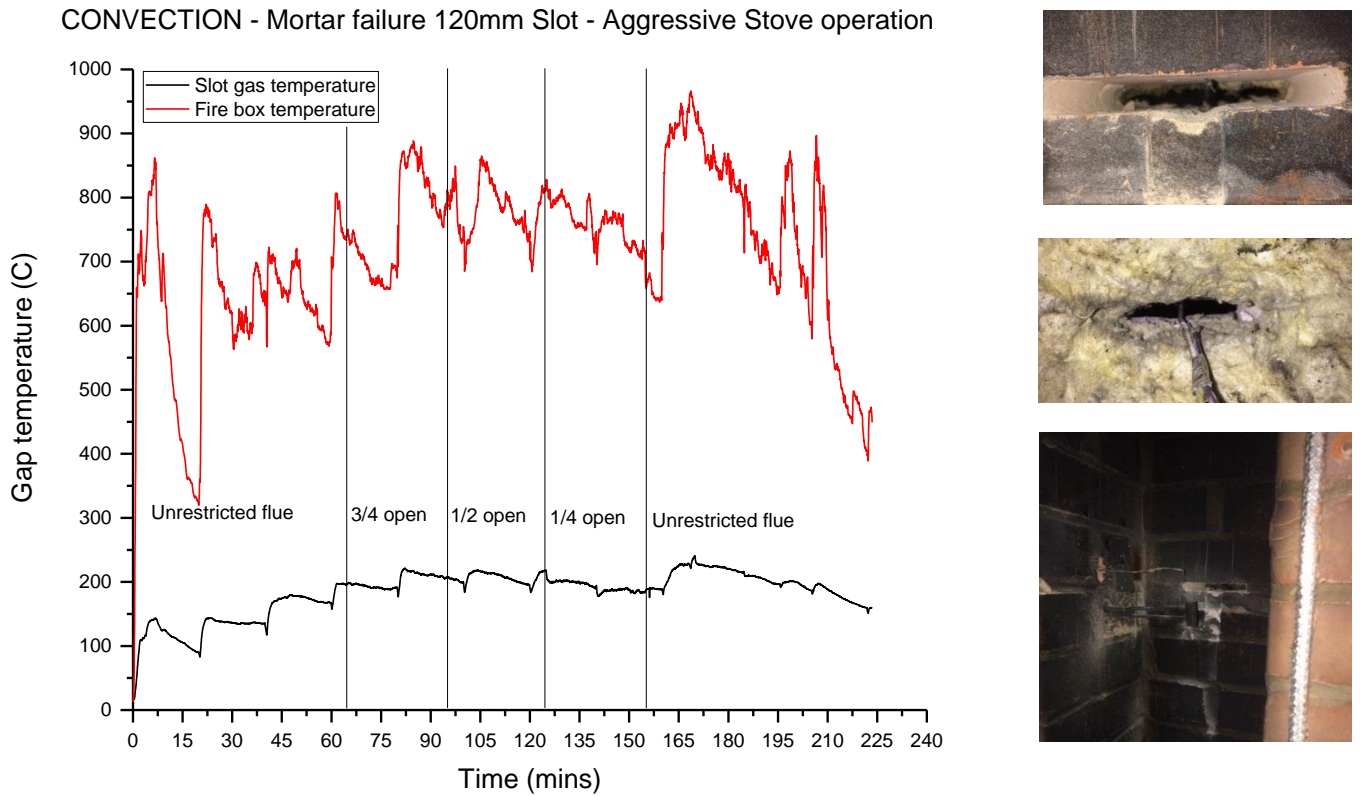
Figure 42 - Convection test through failed mortar joint with aggressive stove operation

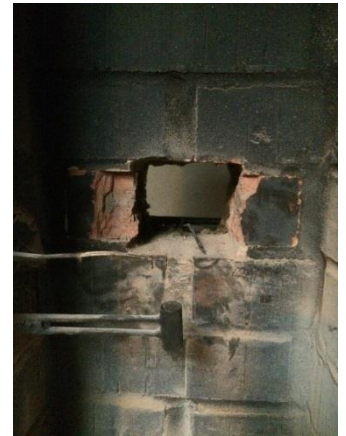
Figure 43 - Convection test through failed brickwork with normal stove operation

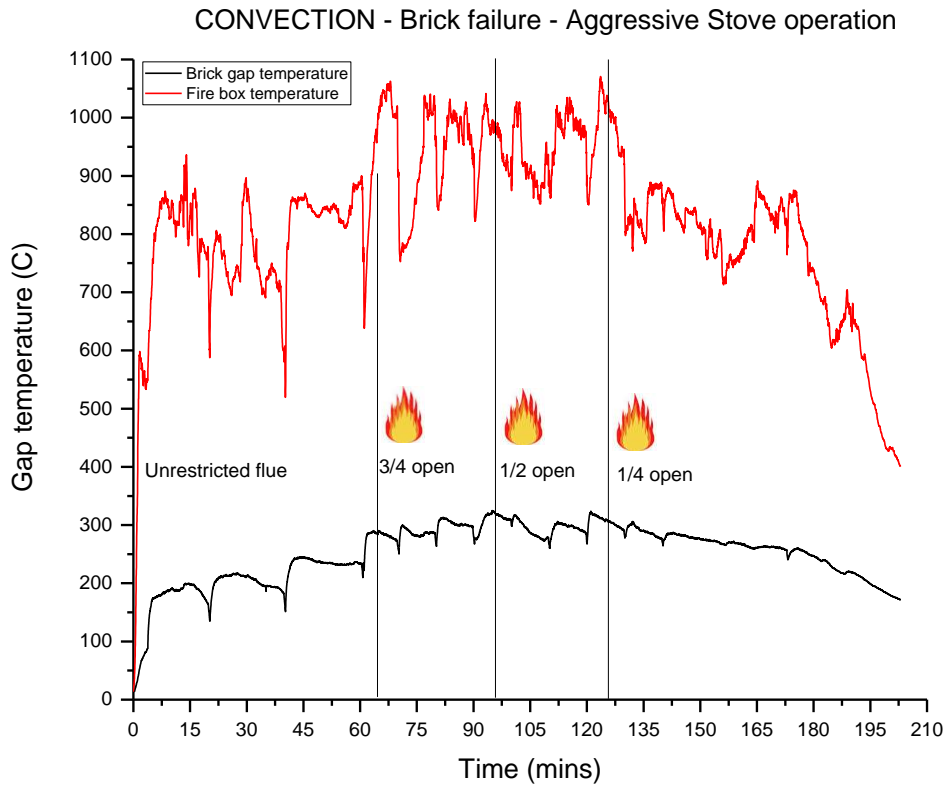
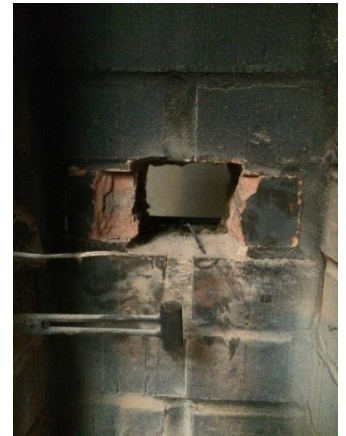
Figure 44 - Convection test through failed brickwork with aggressive stove operation

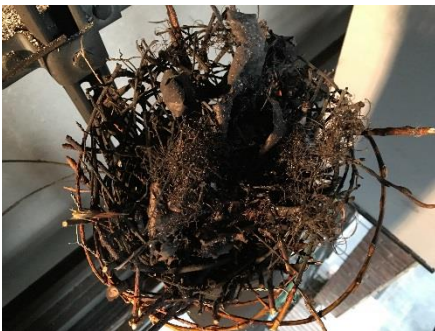
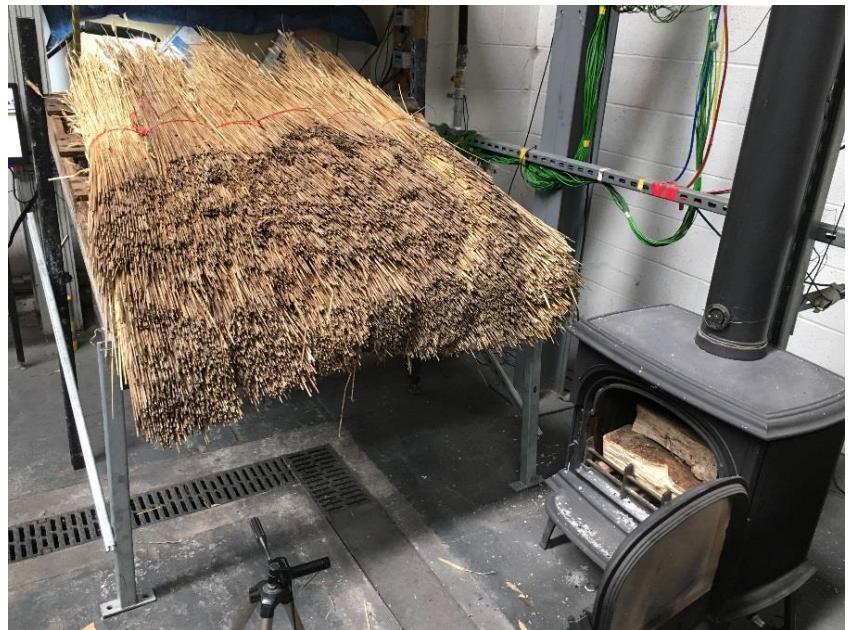
Figure 45 - Bird's nest hazard simulation with thatch below

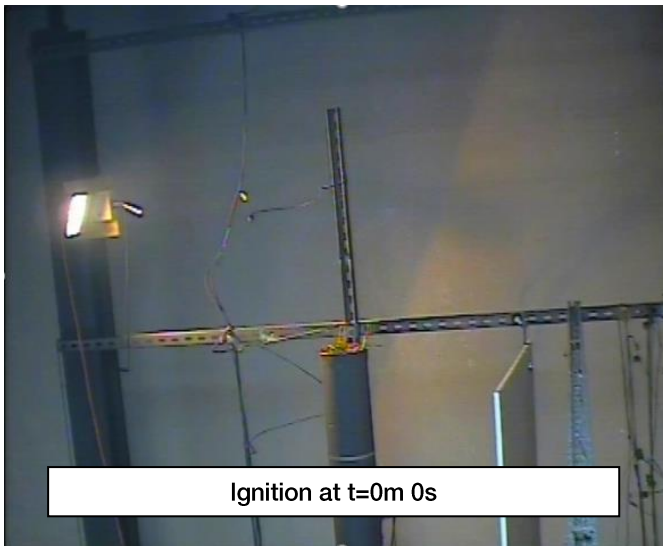
Ignition at t=0m 0s

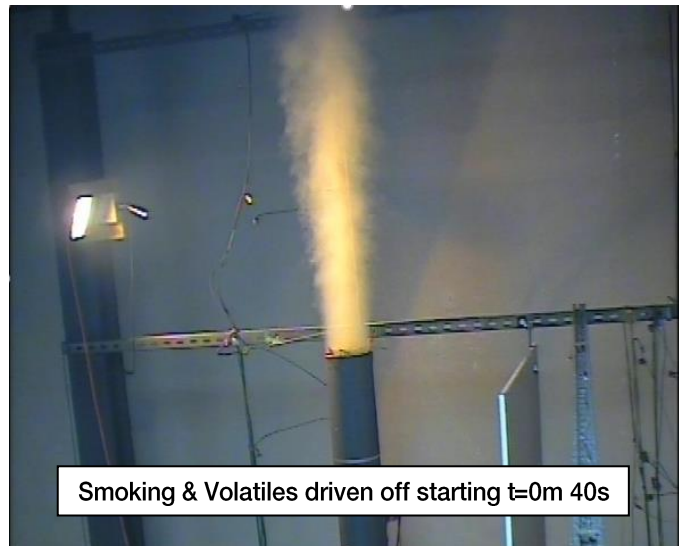
Smoking & Volatiles driven off starting t=0m 40s

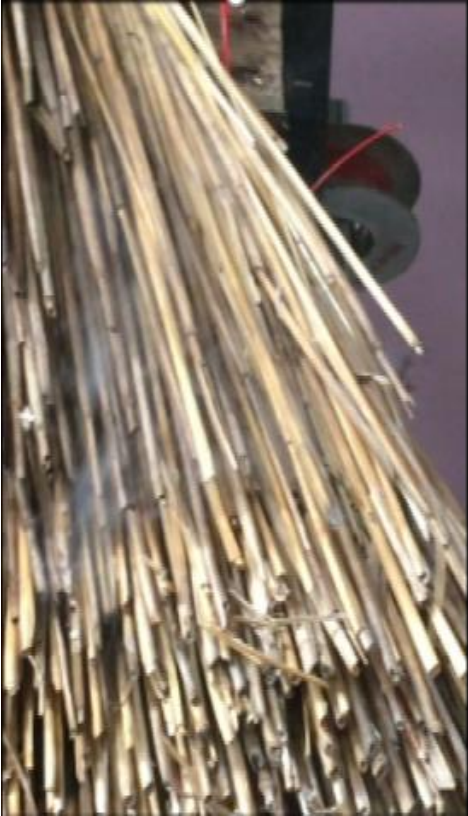
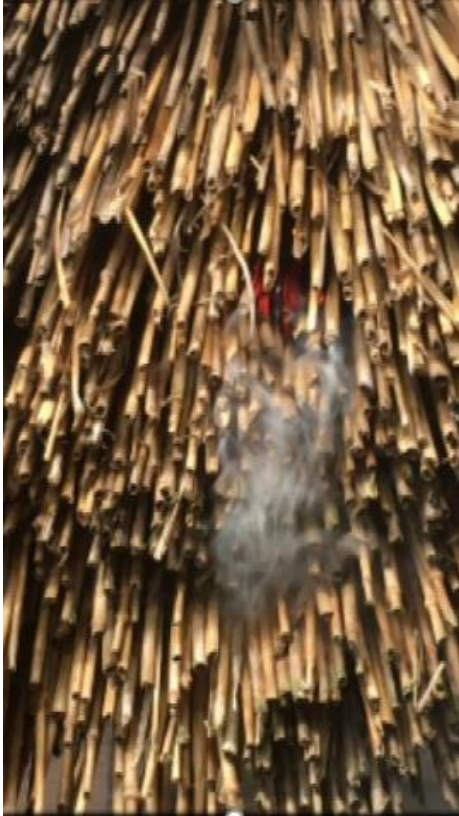
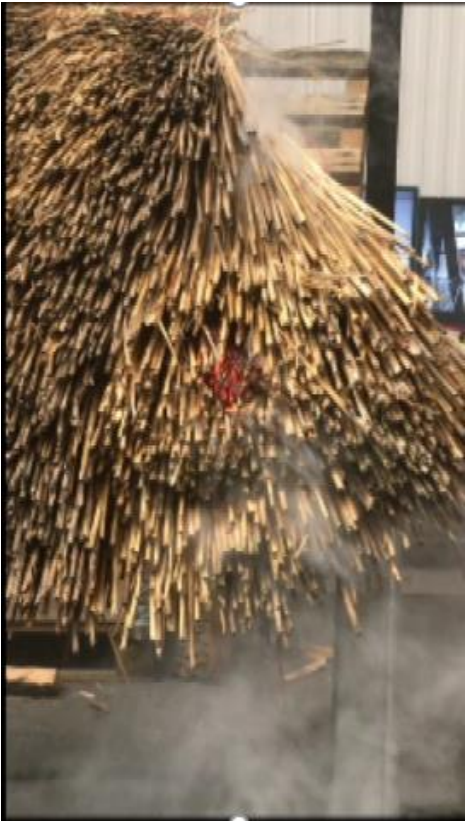
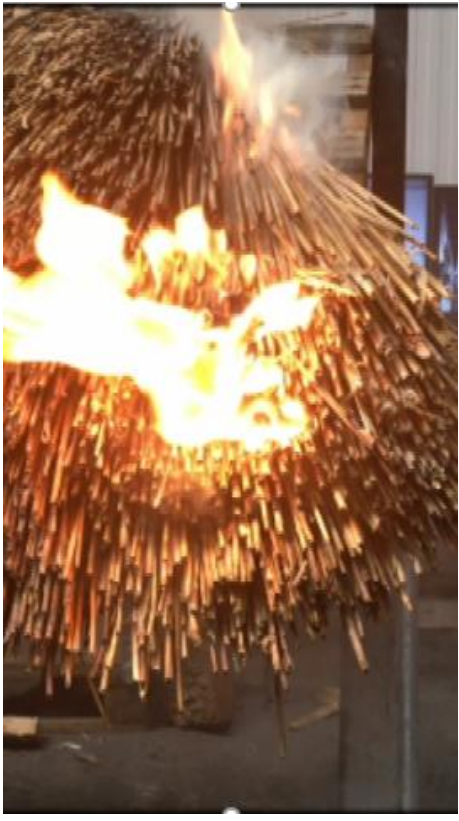
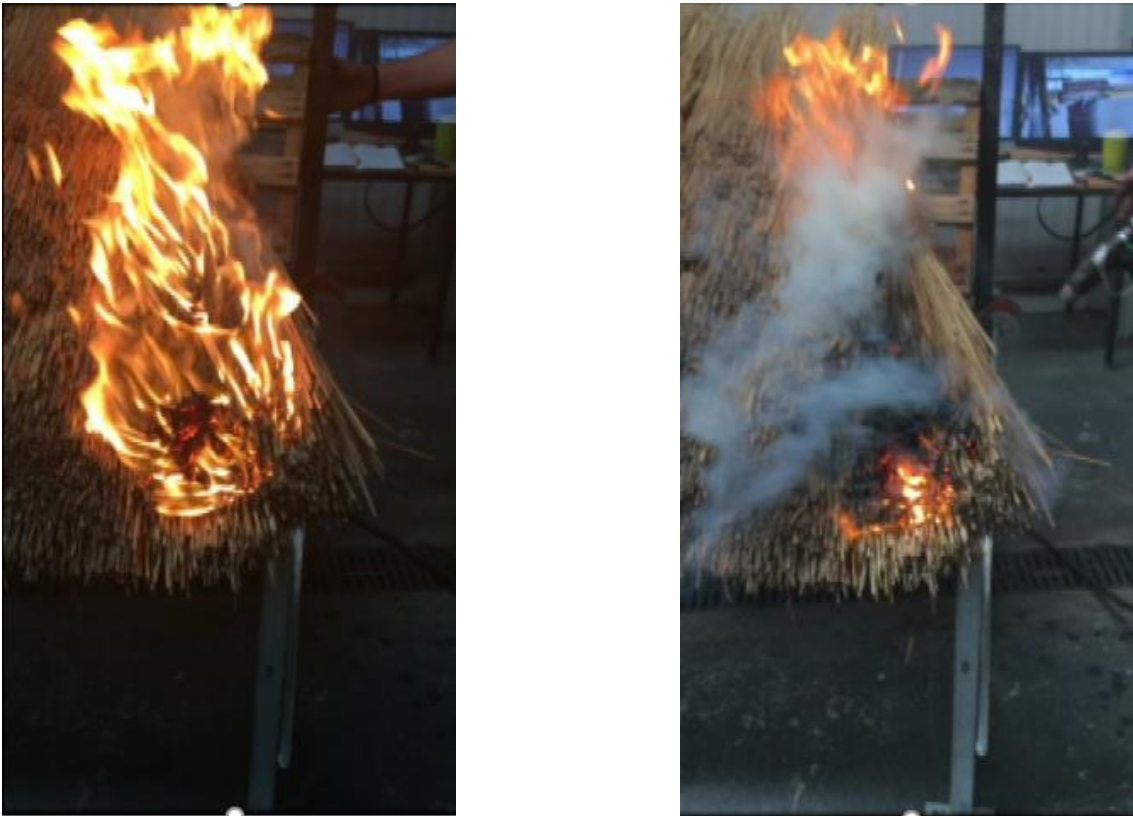
Figure 46 - Photo sequence of bird's nest test

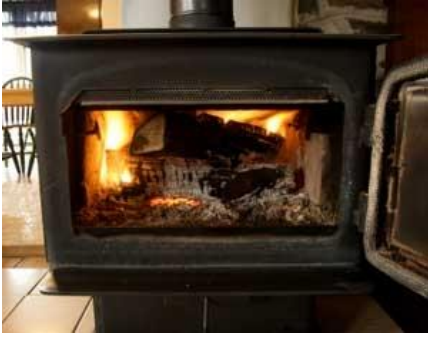
Example of a wood / log burning stove with no ash-pan

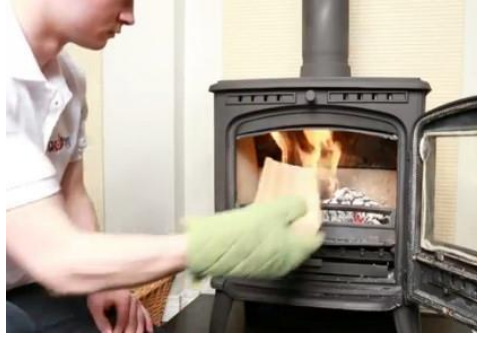
Example of multi-fuel stove with single door providing access for fuel loading and ash-pan removal
